DEPARTMENT OF TRANSPORTATION**DIVISION OF ENGINEERING SERVICES**

Contract #: 04-0120F4Cty: SF/ALA Rte: 80 PM: 13.2/13.9File #: 69.28**WELDING INSPECTION REPORT****Resident Engineer:**Pursell, Gary**Address:** 333 Burma Road**City:** Oakland, CA 94607**Report No:** WIR-012210**Date Inspected:** 17-Feb-2010**Project Name:** SAS Superstructure**OSM Arrival Time:** 700**Prime Contractor:** American Bridge/Fluor Enterprises, a JV**OSM Departure Time:** 1900**Contractor:** Zhenhua Port Machinery Company, Ltd (ZPMC), Changxing Island **Location:** Shanghai, China**CWI Name:** Li Yang and Wu Zhi Cheng**CWI Present:** Yes No**Inspected CWI report:** Yes No N/A**Rod Oven in Use:** Yes No N/A**Electrode to specification:** Yes No N/A**Weld Procedures Followed:** Yes No N/A**Qualified Welders:** Yes No N/A**Verified Joint Fit-up:** Yes No N/A**Approved Drawings:** Yes No N/A**Approved WPS:** Yes No N/A**Delayed / Cancelled:** Yes No N/A**Bridge No:** 34-0006**Component:** OBG Trial Assembly**Summary of Items Observed:**

Segment 6CE to 7AE (Longitudinal Diaphragm) Joint Survey

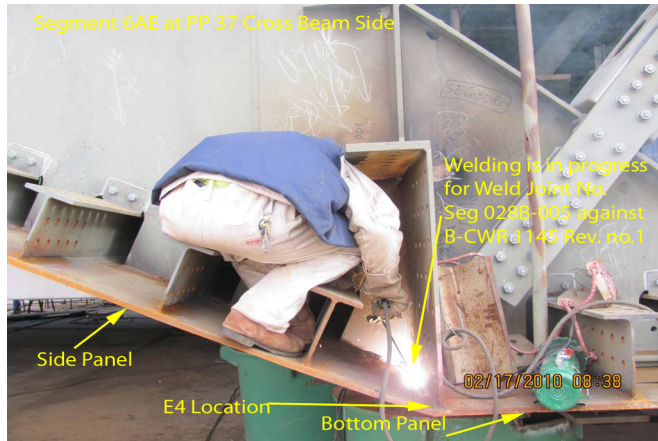
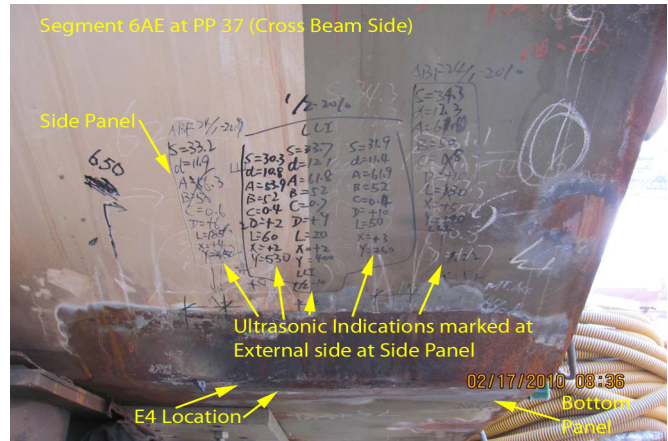
This QA Inspector observed ZPMC welding personnel performing repair welding by Shielded Metal Arc Welding (SMAW) for Weld connecting the Side Panel to Bottom Panel at E4 location Cross Beam side. The weld joint was identified as Seg028B-005. The welding was in progress against the B-CWR 1145 Rev.1 Dated Feb 02, 2010. The welder is identified as 037740. In process SMAW appears to be progressing in compliance with Caltrans Engineer Approved welding procedure i.e., WPS-345-SMAW-1G (1F)-FCM-Repair-1 and WPS-345-SMAW-4G (4F)-FCM-Repair-1. It was observed that the parameters noted down by ZPMC QC are in compliance with WPS, for more comprehensive details please refer the attached pictures.
